# **Discovering & Documenting a “Lost Lighthouse” in Milwaukee’s Lake Park**

## **Phase I Archaeology Survey Report of Findings 2010-2011**

**Kevin M. Cullen (M.S.)  
Archaeology Associate**

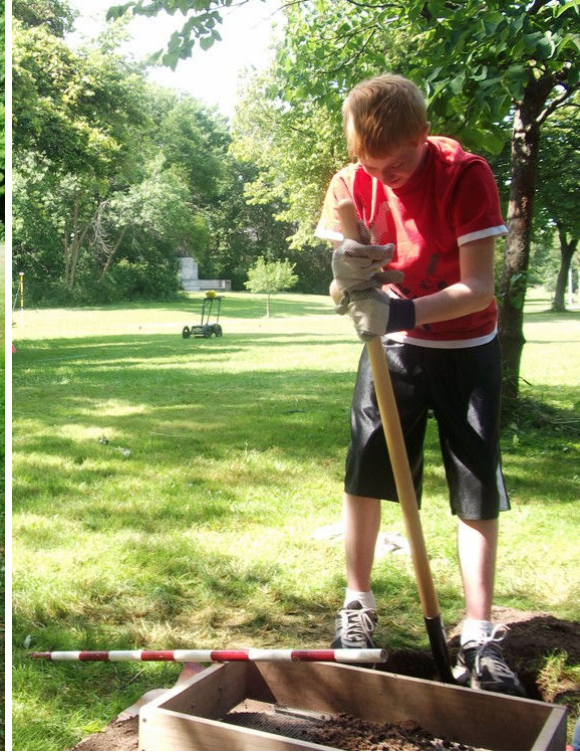
FIGURE 3.2: Shovel Test Excavation Being Performed by Boy Scout

Each shovel test was excavated as a 30-40cm x 30-40 cm square hole aligned in cardinal directions with the survey grid. These shovel tests, were excavated in 10 cm levels, screened through a  $\frac{1}{4}$  wire mesh screen. All artifacts that were encountered were separated per level. The depth of excavations varied depending on soil strata, yet all were terminated 10 cm into the sub clay. Upon excavation completion, a profile illustration was rendered, Munsell soil color and textures described and a photograph of the shovel test profile taken. A total of fourteen shovel tests were excavated during the two days of fieldwork. These results will be described in the following chapter.

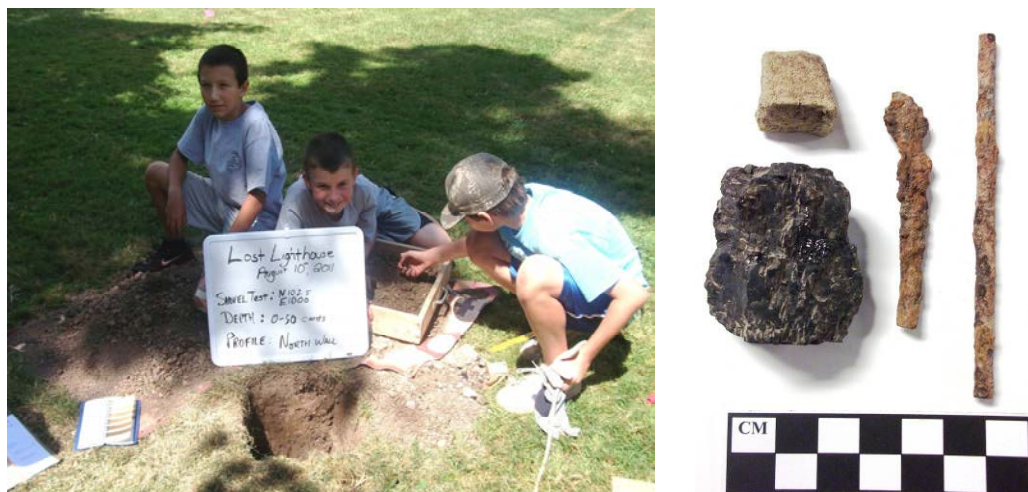
FIGURE 4.3: Shovel Test N1025 E1000 with Recovered Artifacts

**N1025 E1000:** The topsoil A-horizon occurred between 0-12cmbs, below which a fill layer was detected (12-45cmbs). In this mottled clay loam strata large amounts of cinder chunks were observed, one small metal rod, a square nail and a small cream city brick fragment. These artifacts were collected (Fig. 4.3). The excavation was terminated 5cm into the sterile clay at 50cmbs with a munsell color of 10YR 6/4.

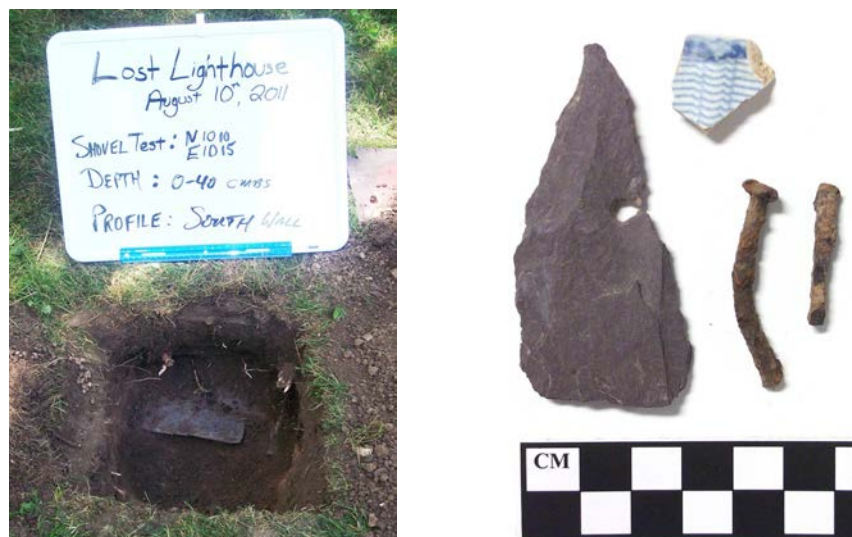
FIGURE 4.4: Shovel Test N1010 E1015 with in situ roof slate at 27 cm below surface, including artifacts recovered from shovel test (note nail hole in slate fragment)

**N1010 E1015:** In this shovel test a two square nails and a small blue-transfer ceramic sherd were found in the A-horizon between 5-30cmbs. Interestingly, a very large roof slate was discovered at 27cmbs and bisected the south half of the shovel test. Because it extended beyond the shovel test parameters, it was left in place; however, a smaller fragment was collected as a sample (Fig. 4.4).

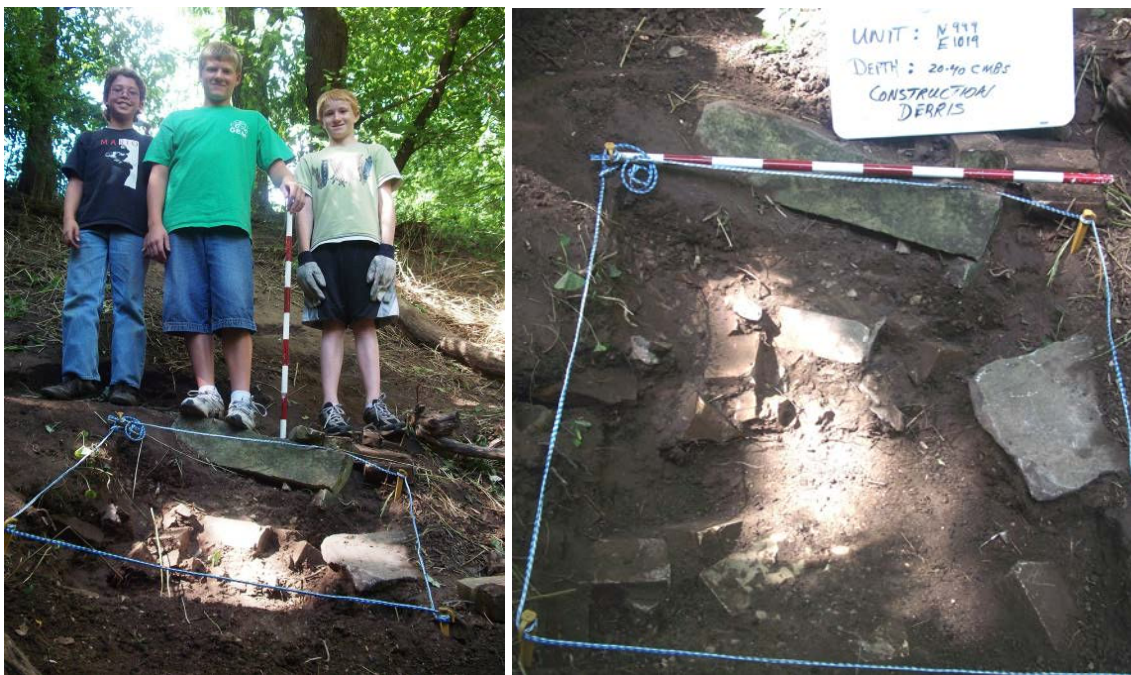
FIGURE 4.5: Unit N999 E1019 (1x1meter) Excavation with boy scouts

In addition to the shovel tests on the upper terrace, a 1x1 meter unit was excavated and exposed on the east bluff embankment. Its coordinates were N999 E1019. This unit yielded abundant evidence of construction material most certainly attributable to the 1855 North Point Lighthouse. Specifically, more than a dozen cream bricks (most were complete), as well as two large fragments of limestone blocks were uncovered but left in situ (Fig. 4.5). The unit was excavated to a maximum depth of 40 cm below the current slope, whereby exposing a midden of cream brick and limestone blocks. 19<sup>th</sup> Century artifacts that were observed and collected between 0-40cm below the surface include: Blue transfer print ceramics, stoneware, a sawn faunal bone, an iron door hinge, a shell button and a fragment of a glass gaming marble (Fig. 4.6). In all likelihood these artifacts are from the occupants of the former lighthouse and keepers quarters.
